TESTS OF EFFECTS OF LONG DURATION BLAST-TYPE FLOWS ON FIRES IN
INTERIORS (INCLUDING EOC'S)

INTERIM TESTS OF THE EFFECTS OF LONG DURATION BLAST-TYPE FLOWS ON FIRES IN URBAN INTERIORS AND ON THE CONTENTS OF EMERGENCY OPERATING CENTERS (EOC)

C. Wilton
R. Kaplan
SCIENTIFIC SERVICE, INC.
1536 Maple Street
Redwood City, California 94063

Contract No. DAHC20-73-C-0195
DCPA Work Unit 2563A
COTR - Dr. Michael A. Pachuta

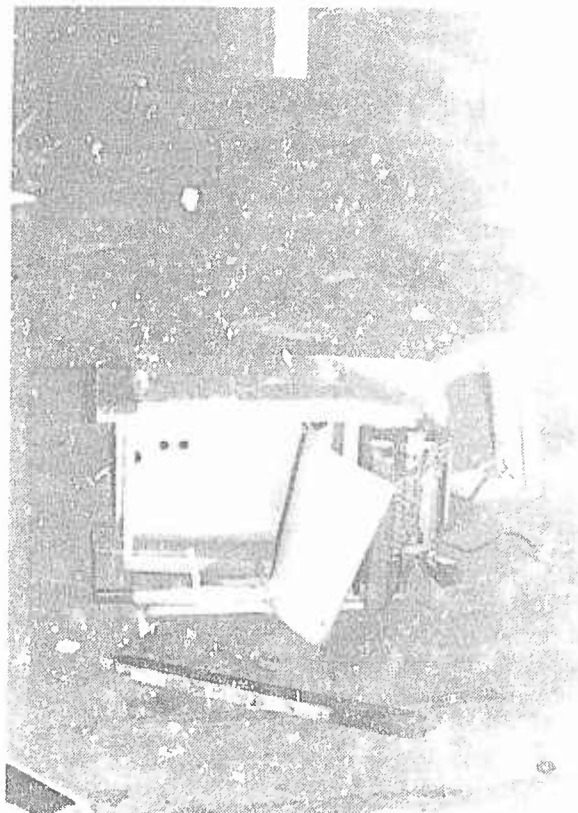
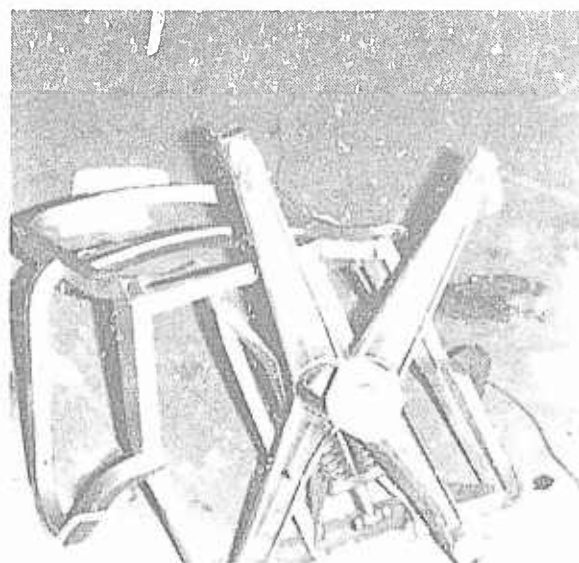
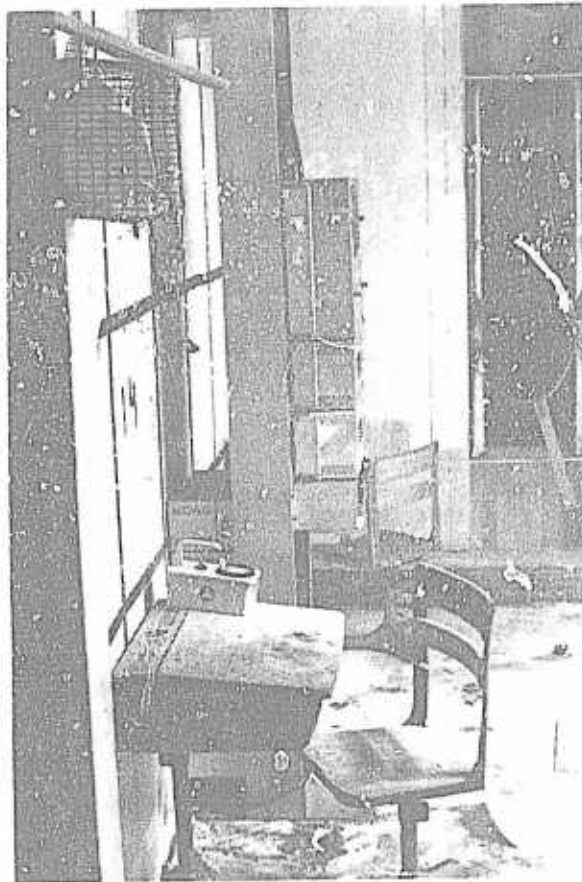
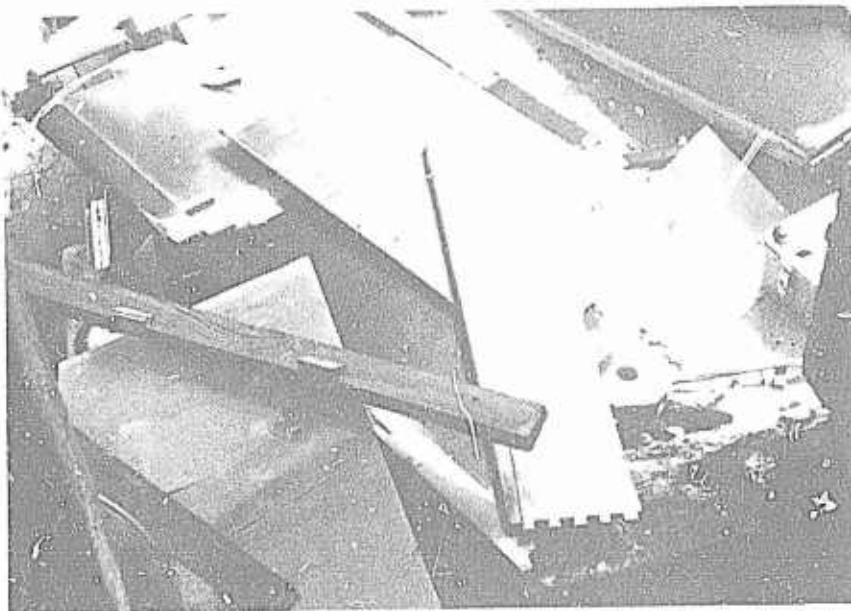
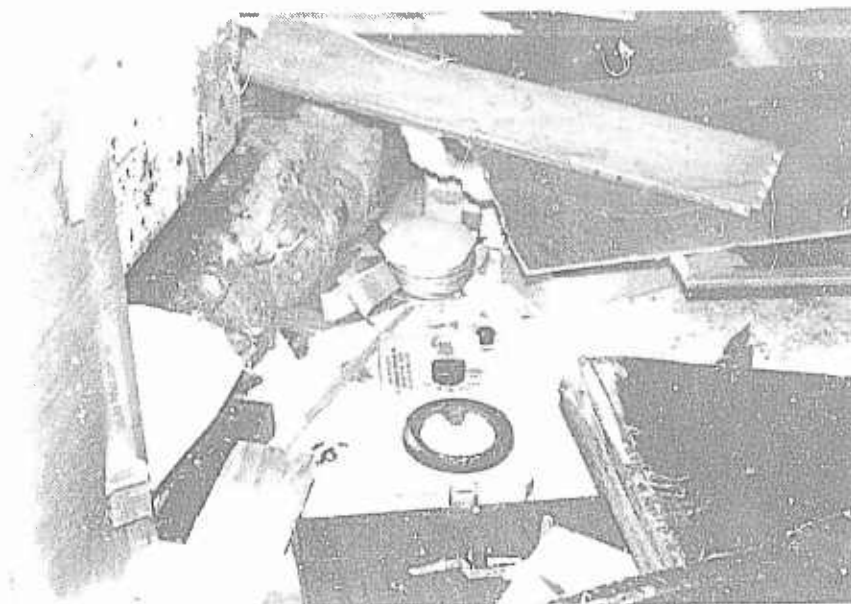
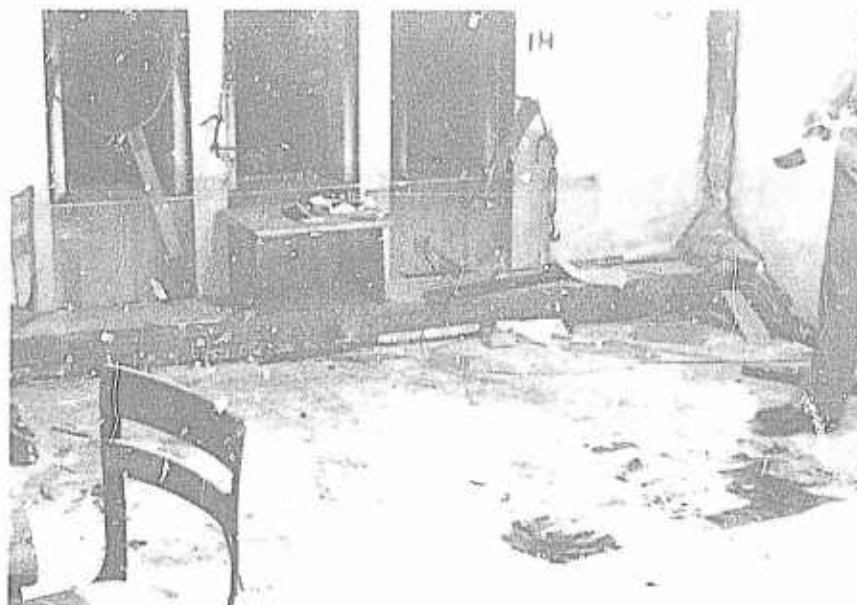
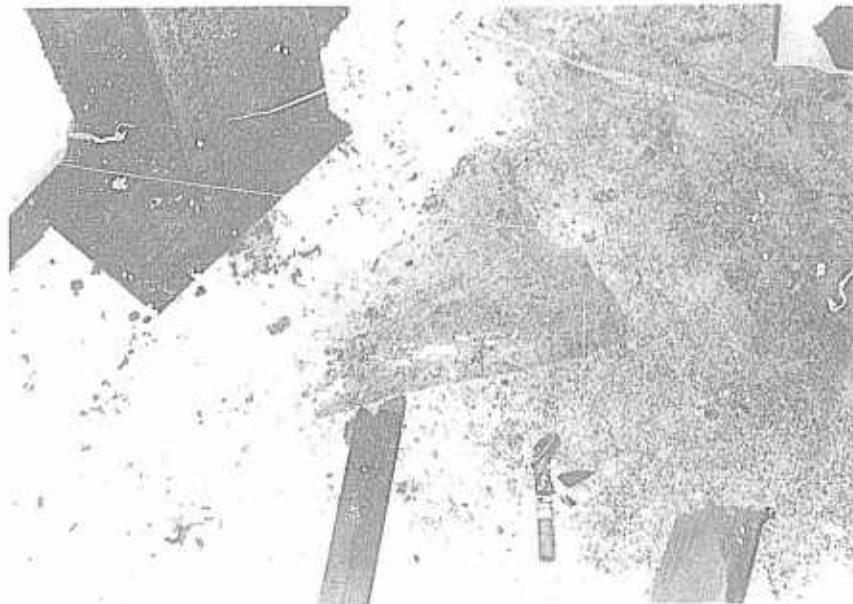
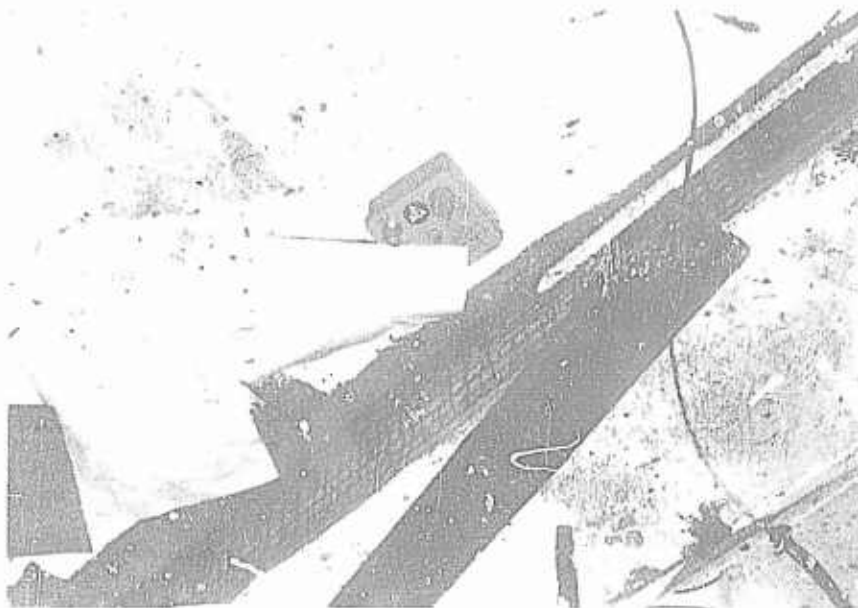
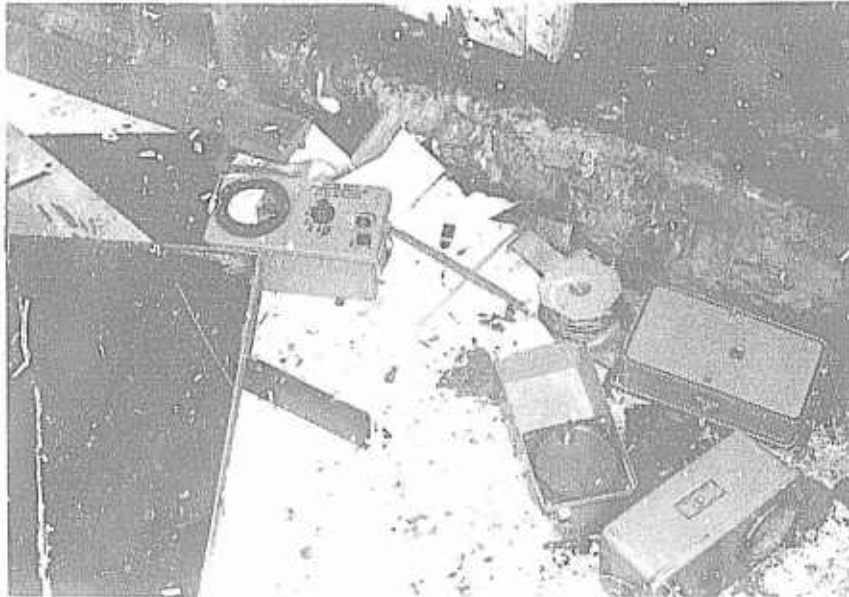
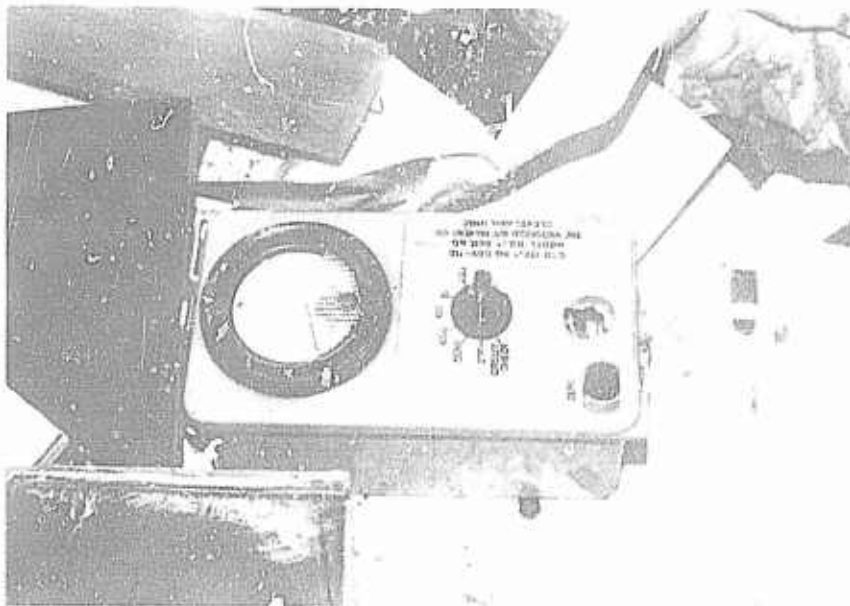
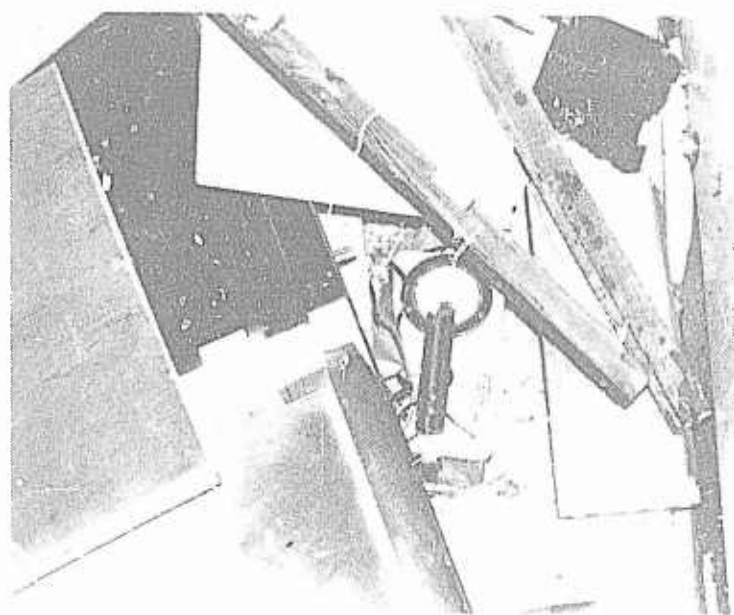
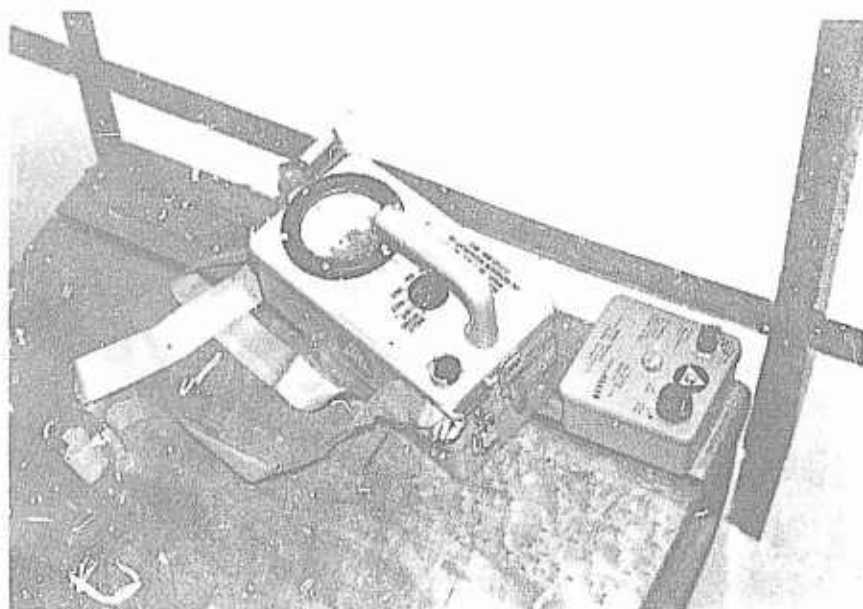
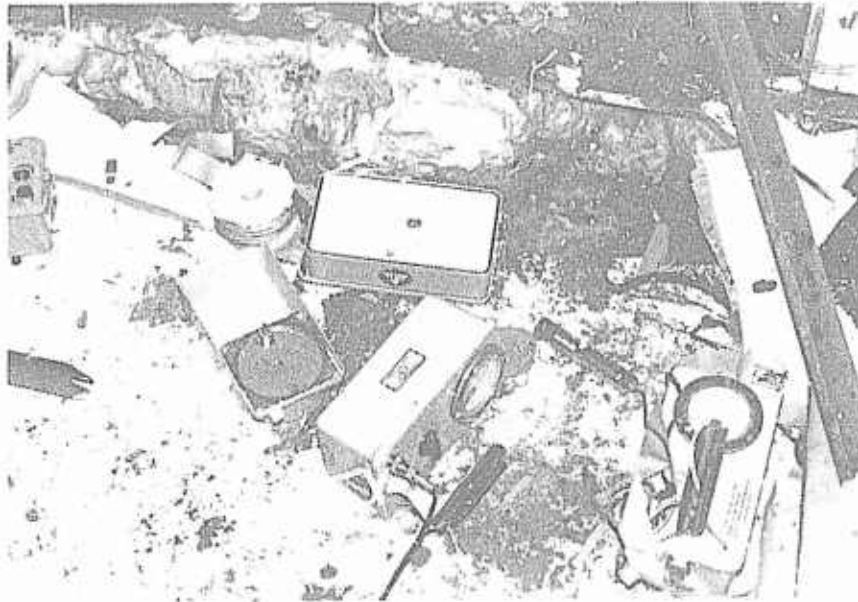
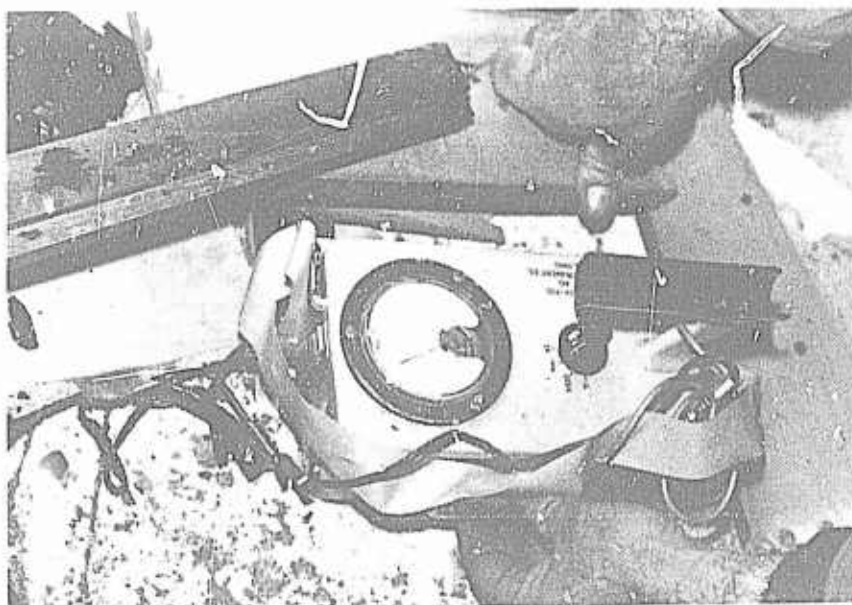
The pretest arrangement (including the above items of equipment) is shown in Figs. 14-2 through 14-6. The blast severely damaged the desk, originally located in the center of the room. The top was broken in half and was found in front of the doorway. Most of the remainder of the desk was found outside the door in the hallway. The teletype and chair were heavily damaged and were found in the outside corridor. The chair was 17 ft from the doorway and the teletype 38 ft. Items 1, 2, 5, and 7 were found in front of the doorway under the debris from the desk. All were damaged and only two of them showed any response when turned on. Item 4 (dosimeter) was badly damaged and was found near the back wall. All other items were undamaged. Posttest photographs from this test are presented in Figs. 14-7 through 14-14.

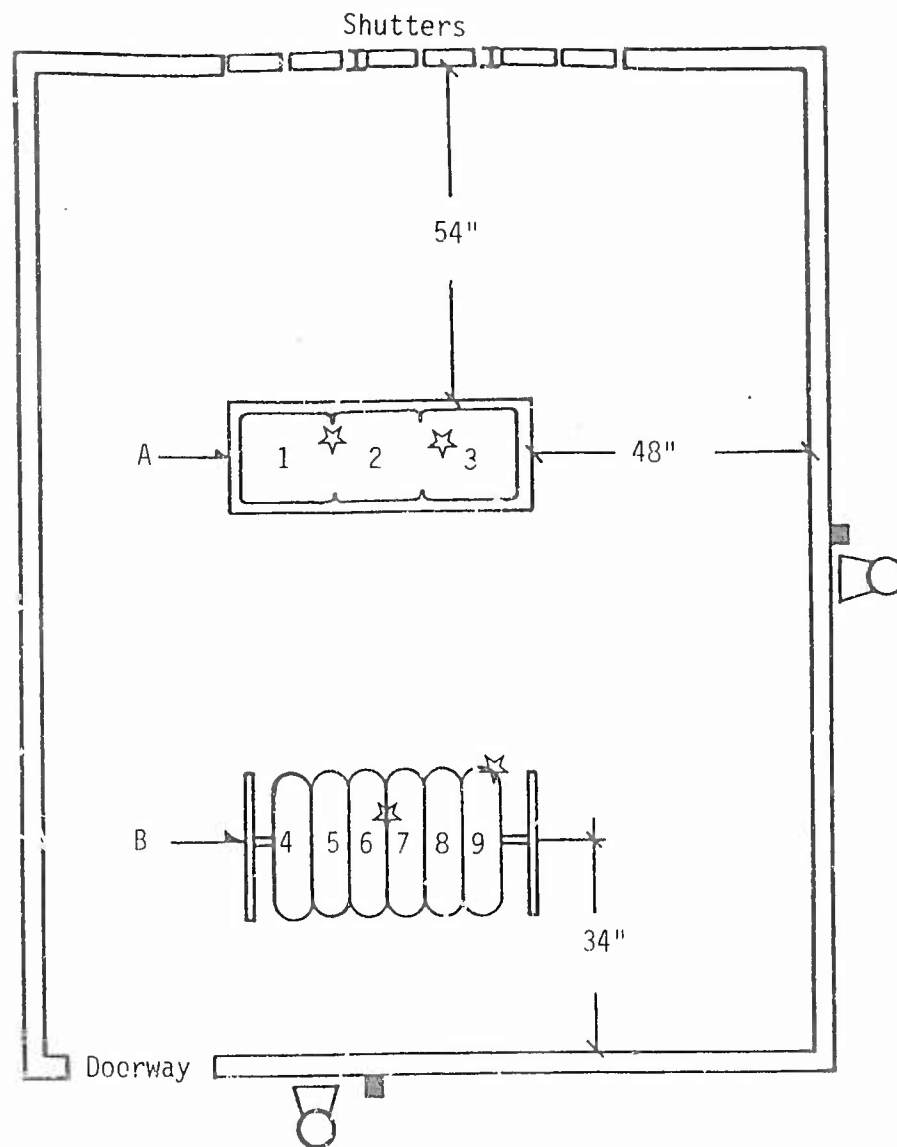
Fig. 15-1. Sketch of Test Geometry, Test Number 15

- A - 50 x 18 in. table
- B - 49 in. long, 60 in. high clothes rack
- 1 - terry cloth
- 2 - denim
- 3 - mixed duck and muslin
- 4, 7, & 8 - muslin
- 5, 6, & 9 - duck
- ☆ Ignition sources

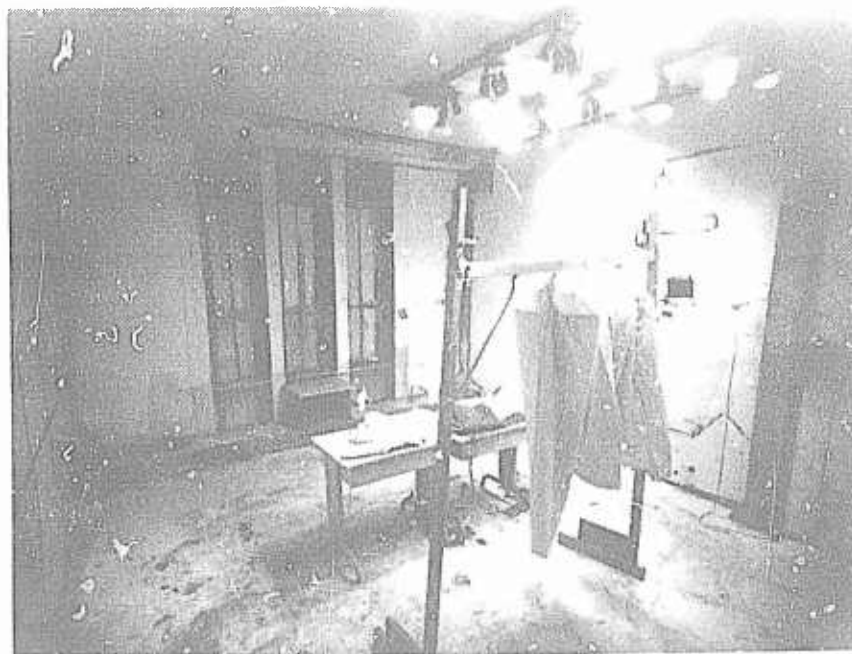
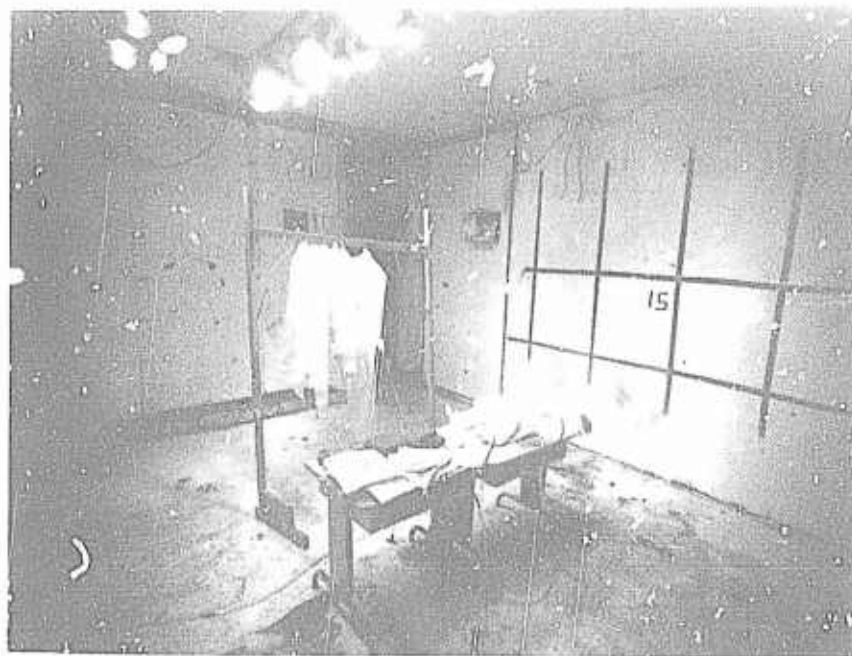
Fig. 15-2. Pretest Photographs, Test Number 15

The general contents and arrangement of this simulated clothing store were the same as those used in Tests 6 and 11. As sketched in Fig. 15-1, tables containing folded pieces of terry cloth, muslin, denim, and drill were placed upstream from a rack from which hung pieces of drill and muslin. The photographs of Fig. 15-2 are two pre-test views of the room which show the materials as well as the piloted propane ignition sources.

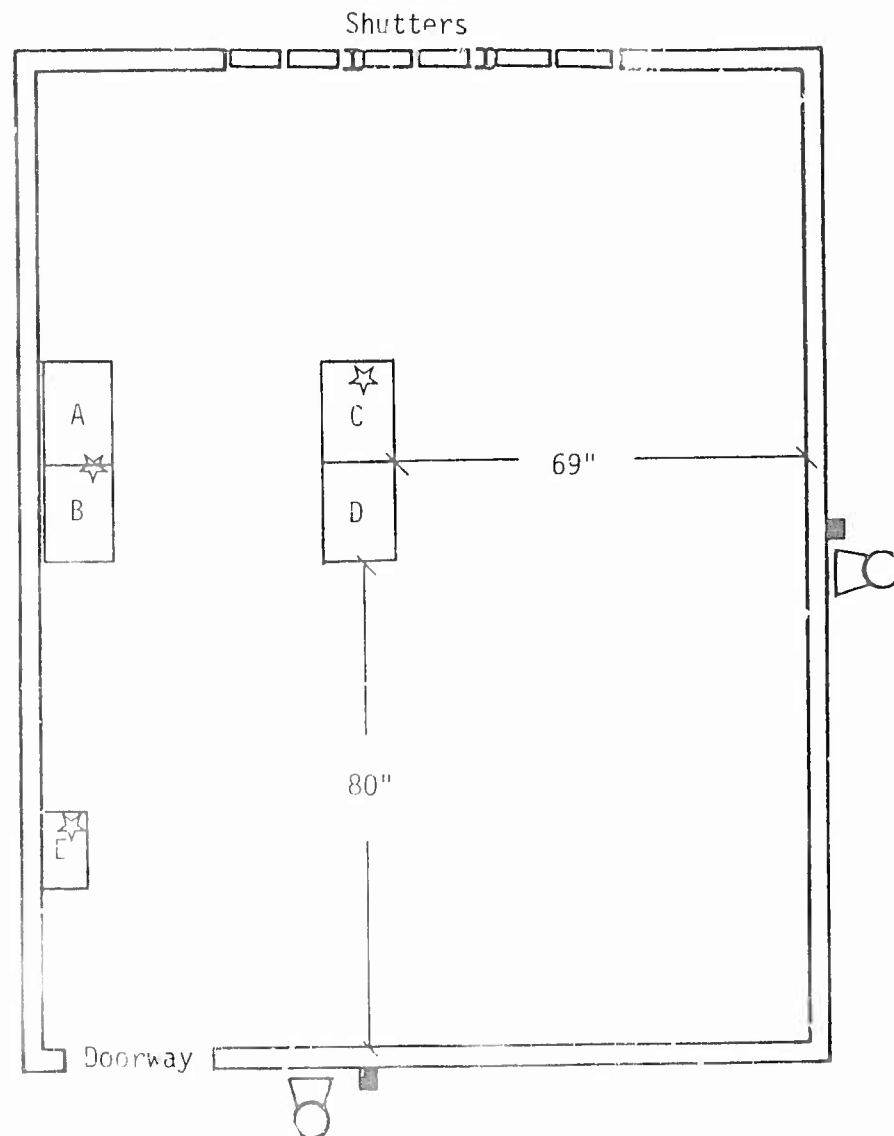
Fig. 16-1. Sketch of Test Geometry, Test Number 16

The basic test geometry was very similar to that of Test 13, with two, lead-weighted, empty boxes along the side wall near the rear doorway, and a stack of boxes, two deep and three high, containing fairly large amounts of uncrumpled paper, was placed in the center of the room. One feature added for this test was an 8.5 in. x 12.5 in. x 8 in. wire cage (actually a guinea pig cage) near the doorway in which papers were placed and ignited. This was the first of the "confined fuel" tests designed to investigate the effect of preventing burning elements from being transported out of the test room. Fig. 16-1 is a sketch of the room arrangement; the pretest photographs of Fig. 16-2 show the wire cage in place, and the location of ignition sources.

- A & B - 17 x 13 x 13 in. cardboard box (weighted, no paper)
- C - 17 x 13 x 13 in. cardboard boxes stacked three high (containing crumpled paper)
- D - 17 x 13 x 13 in. cardboard boxes stacked three high (empty)
- E - 8.5 x 12.5 x 8 in. wire cage containing crumpled paper
- ☆ Ignition sources

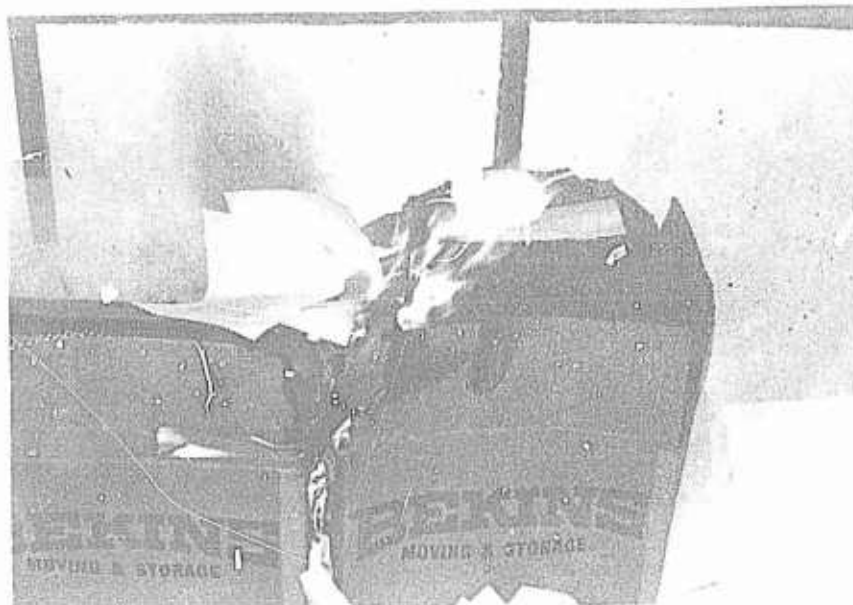
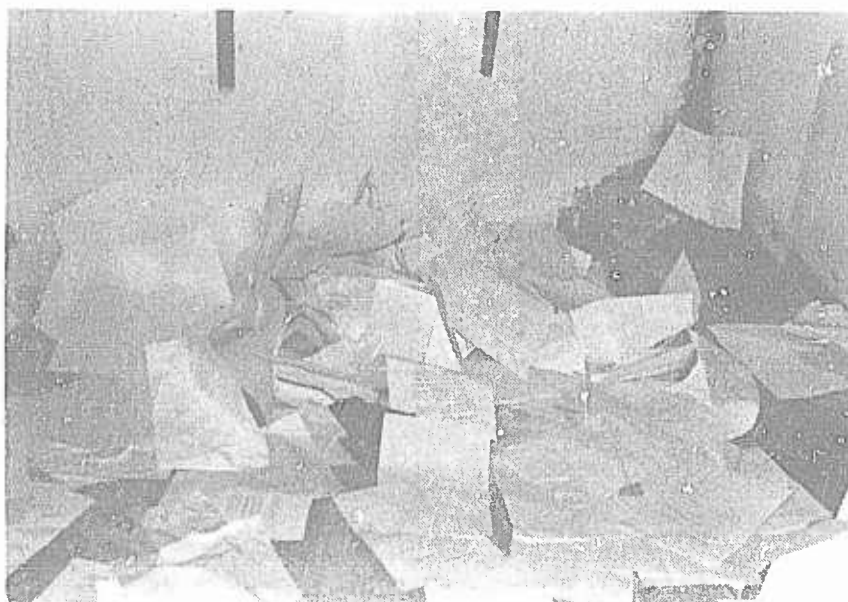
Fig. 16-4. Posttest Photographs, Test Number 16

ber pressure of Test 7 was about 2 psi, and that of Test 13 about 4 psi.) All burning materials from the center stack were extinguished and large masses of unburnt paper from that stack were distributed about the room, (particularly into the corners, Fig. 16-4) and ejected through the doorway into the corridor behind the room (see Fig. 16-3). Flames were extinguished in the weighted boxes along the side wall, but they continued to smoulder, and rekindled in about 10 minutes as shown in Fig. 16-4.

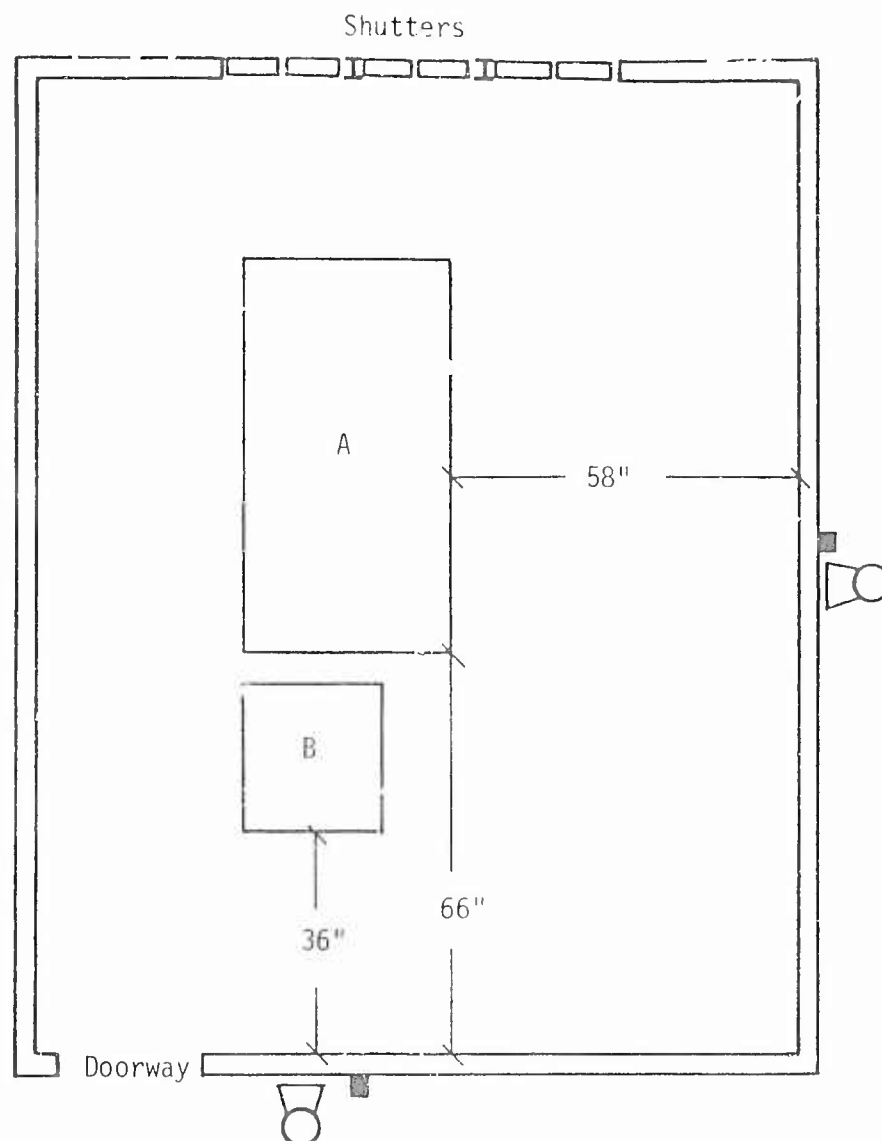
Fig. 17-1. Sketch of Test Geometry, Test Number 17

The simulated EOC test geometry is sketched in Fig. 17-1. The equipment tested included a desk on which was placed three telephones and three small radios. Placed next to the desk was a tall relay rack (previously used in test 14). Photographs of this equipment prior to the test are shown in Figs. 17-3 through 17-5 (lower photograph).

- A - 36 x 66 in. desk containing three telphones and three radios
B - 24 x 24 in. communications rack

The simulated EOC test geometry is sketched in Fig. 17-1. The equipment tested included a desk on which was placed three telephones and three small radios. Placed next to the desk was a tall relay rack (previously used in test 14). Photographs of this equipment prior to the test are shown in Figs. 17-3 through 17-5 (lower photograph).

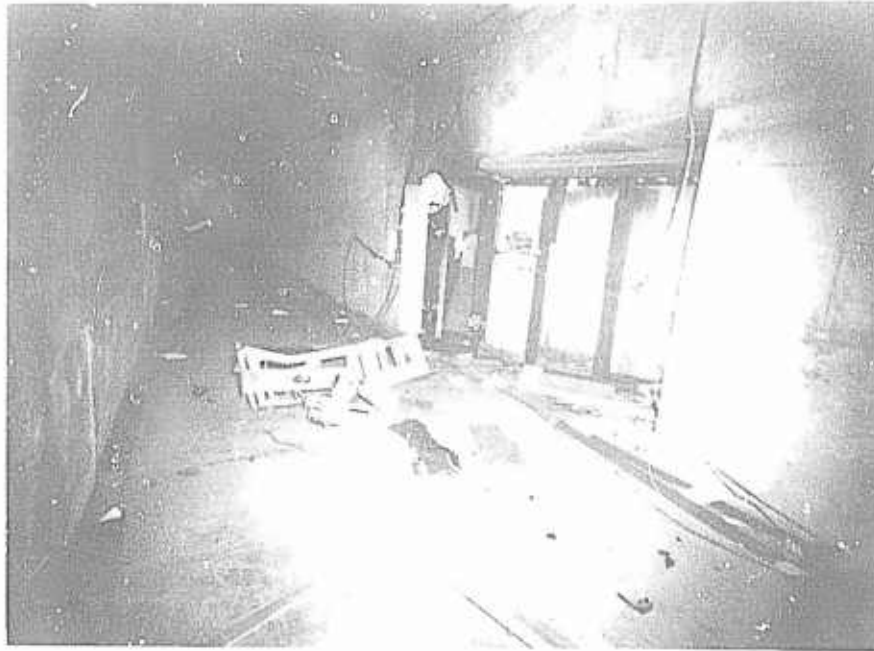
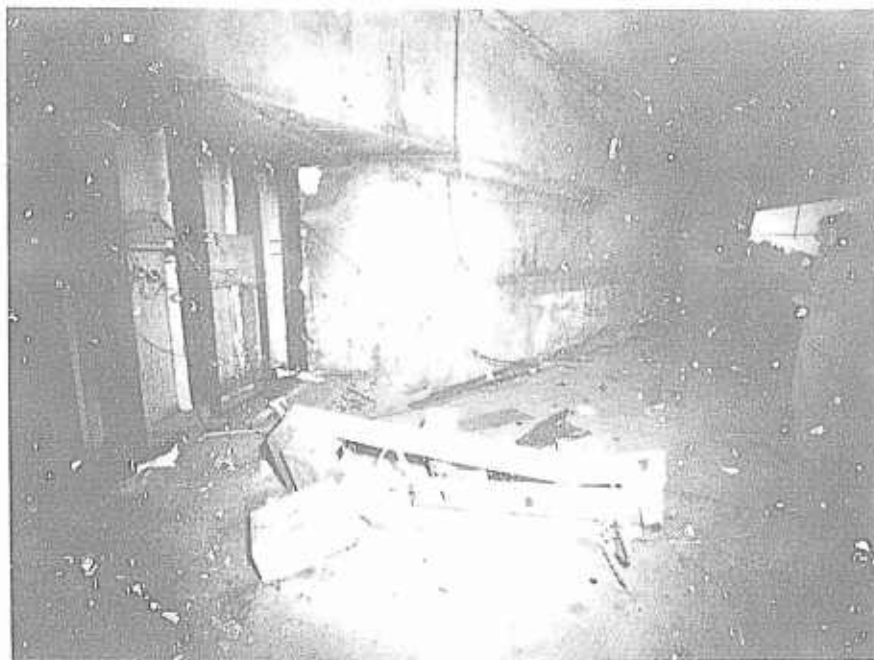
Fig. 17-7. Posttest Photographs, Test Number 17

The blast damaged all of the equipment. Pieces of telephones and radios were scattered as far as 50 ft from the doorway (see Fig. 17-8). The relay rack was outside the test room in the corridor about five feet from the doorway and was severely damaged, see Figs. 17-7, 17-9 and 17-10 (lower photograph) and 17-11 (upper photograph).

The blast damaged all of the equipment. Pieces of telephones and radios were scattered as far as 50 ft from the doorway (see Fig. 17-8). The relay rack was outside the test room in the corridor about five feet from the doorway and was severely damaged, see Figs. 17-7, 17-9 and 17-10 (lower photograph) and 17-11 (upper photograph).

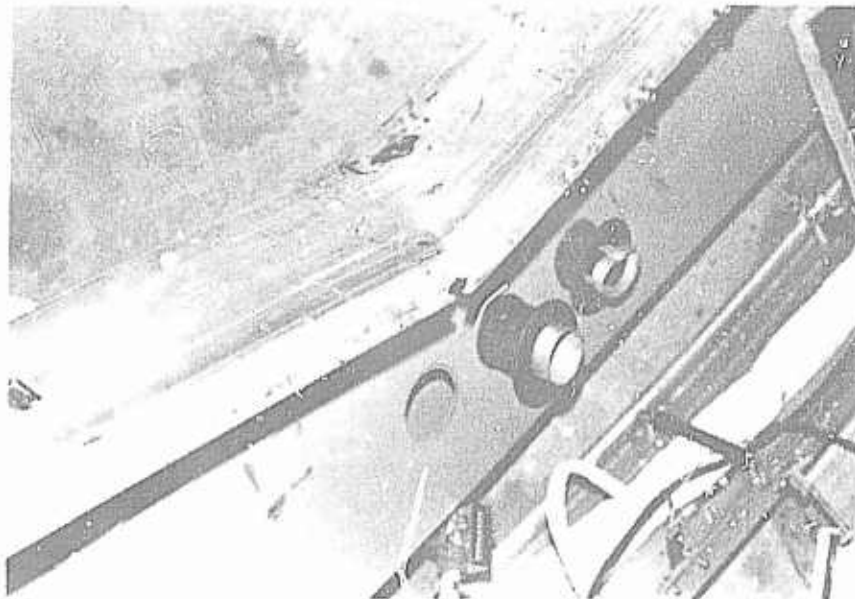
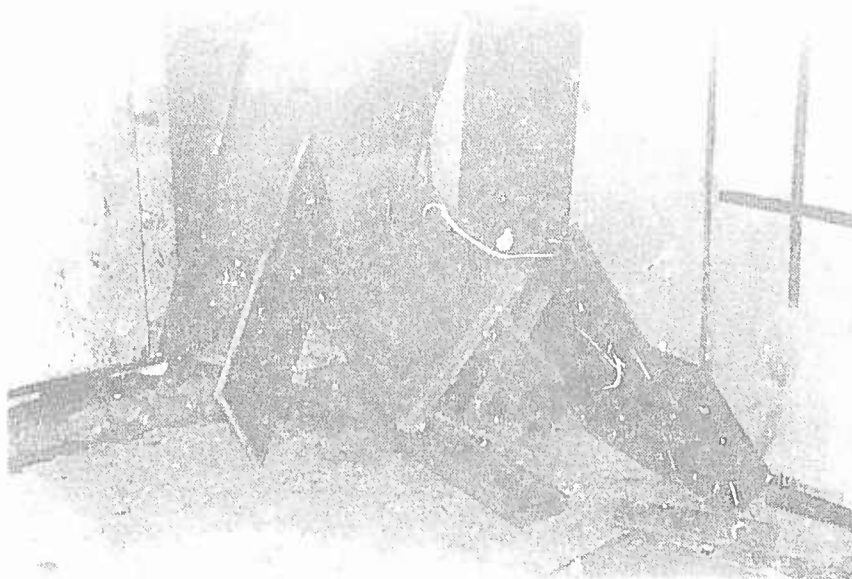
Fig. 17-11. Posttest Photographs. Test Number 17

The desk was broken up and piled in the doorway as shown in Fig. 17-11 (lower photograph).

The desk was broken up and piled in the doorway as shown in Fig. 17-11 (lower photograph).

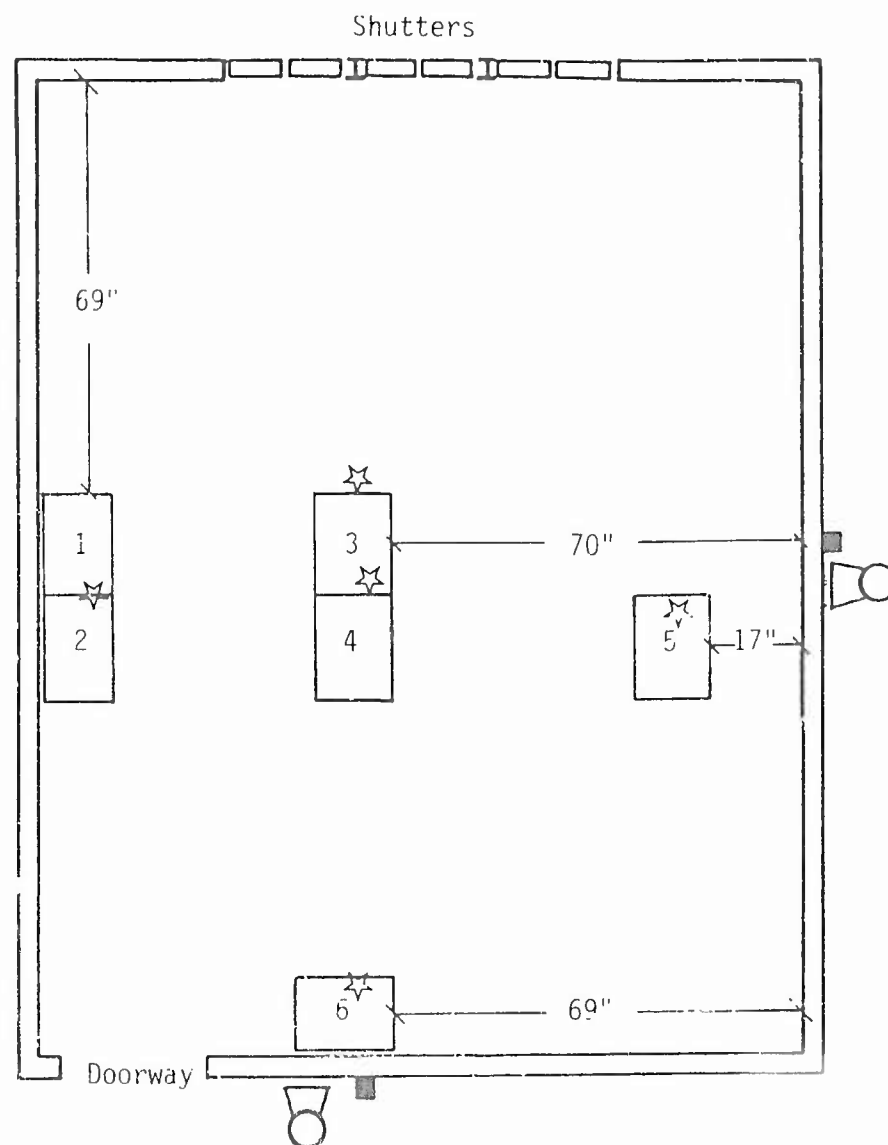
Fig. 18-1. Sketch of Test Geometry, Test Number 18

This test had the same basic warehouse configuration used in the last two tests (13 and 16) with certain additions designed to investigate whether the smouldering fires that occurred in the empty weighted boxes located along the side wall near the doorway and that reignited later could also exist in other areas of the room. The question was whether the cause of these fires was the location of the fuel or the type of fuel. Therefore, in addition to placing the central stack of six boxes containing a large quantity of paper in the center of the room and the two empty weighted boxes along the side wall, an empty weighted box was placed along the rear wall and another between the center stack and the side wall away from the doorway. The configuration is shown in Fig. 18-1 and the photographs of Fig. 18-2.

In contrast, all fires in the weighted boxes were not extinguished. The two side boxes (numbers 1 and 2 in Fig. 18-1) were flaming within 30 seconds after the shot and the box near the other side wall (number 5) was smouldering, although the smouldering fire did eventually go out.

- 1, 2, 5, & 6 - 17 x 13 x 13 in. cardboard boxes (weighted, no paper)
- 3 - 17 x 13 x 13 in. cardboard boxes stacked three high (full of paper)
- 4 - 17 x 13 x 13 in. cardboard boxes stacked three high (top full of paper)
- ☆ Ignition sources

This test had the same basic warehouse configuration used in the last two tests (13 and 16) with certain additions designed to investigate whether the smoldering fires that occurred in the empty weighted boxes located along the side wall near the doorway and that reignited later could also exist in other areas of the room. The question was whether the cause of these fires was the location of the fuel or the type of fuel. Therefore, in addition to placing the central stack of six boxes containing a large quantity of paper in the center of the room and the two empty weighted boxes along the side wall, an empty weighted box was placed along the rear wall and another between the center stack and the side wall away from the doorway. The configuration is shown in Fig. 18-1 and the photographs of Fig. 18-2.

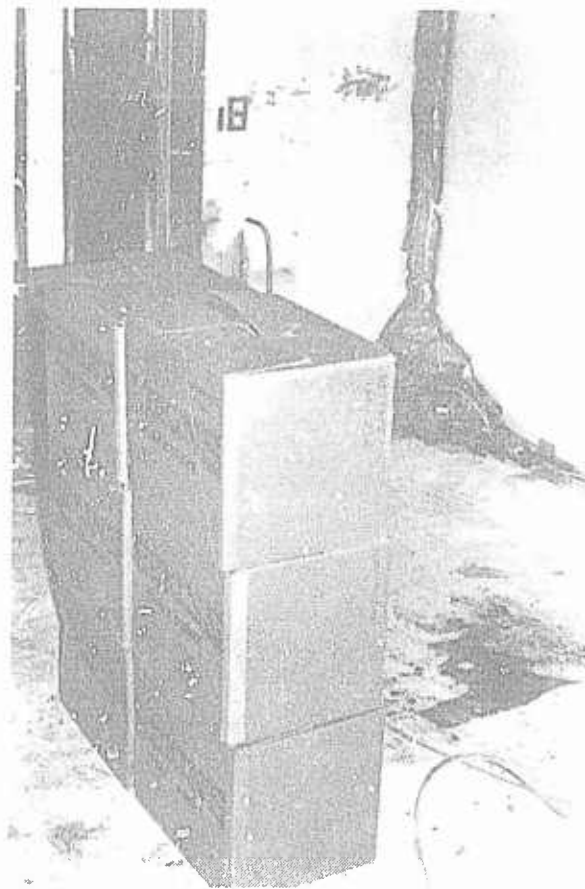
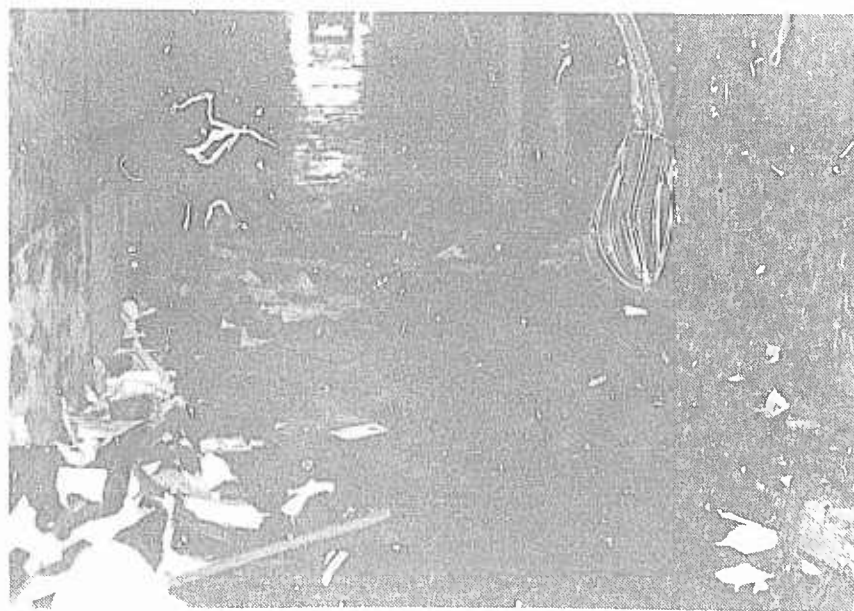
Fig. 18-3. Pre and Posttest Photographs, Test Number 18

ignited, that is, they ignited by the pilot light (Fig. 18-3) before the supply of propane was increased to form a long flame that was supposed to ignite the boxes. As a result of this, the fire in the central stack was very well established; its entire top and a good deal of the paper within the top boxes were flaming vigorously at the time of the shot. Despite this, all flames in this material were extinguished, and -- as before -- the contents of the stack were distributed widely throughout the room, and in the corridor behind the rear doorway.

ignited, that is, they ignited by the pilot light (Fig. 18-3) before the supply of propane was increased to form a long flame that was supposed to ignite the boxes. As a result of this, the fire in the central stack was very well established; its entire top and a good deal of the paper within the top boxes were flaming vigorously at the time of the shot. Despite this, all flames in this material were extinguished, and -- as before -- the contents of the stack were distributed widely throughout the room, and in the corridor behind the rear doorway.

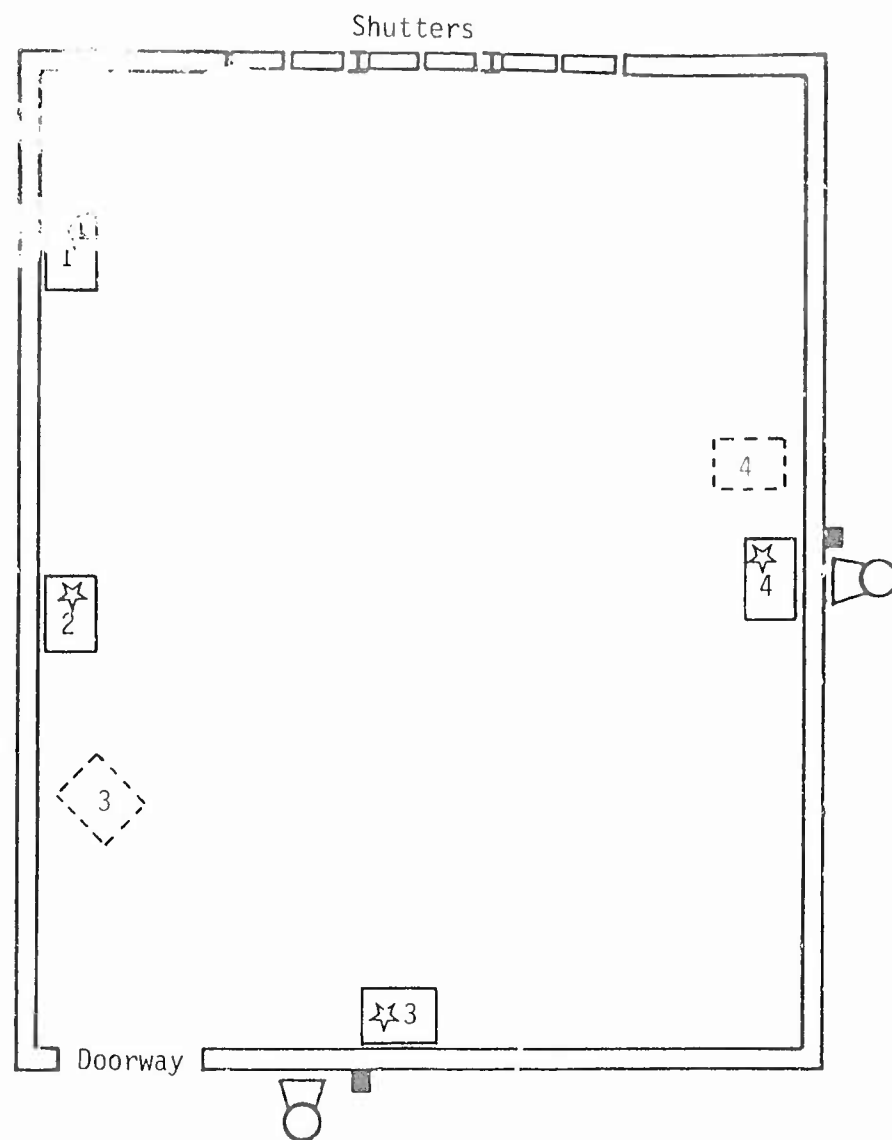
Fig. 19-1. Sketch of Test Geometry, Test Number 19

In this test, all fuel (paper) was confined to four cages similar to the single cage used during Test 16. These were placed: against the side wall nearest the doorway, one fairly close to the shutters (cage 1), the other near the center of the room (cage 2); along the rear wall directly opposite the shutters (cage 3); and near the side wall farthest from the doorway, about halfway between the front and rear walls (cage 4). The configuration adopted is shown in Fig. 19-1. The top part of Fig. 19-2 is a pretest photograph of cages 1 and 2, and the lower part, a photograph of cage 4. Cage 3 is in the top photograph of Fig. 19-3.

After the shot the contents of cages 1 and 2 were found totally consumed; the fires were extinguished in cages 3 and 4, which were displaced as shown in Fig. 19-1. This suggests that cages 1 and 2 were away from the direct high velocity flow between the window and the doorway, that

1, 2, 3, & 4 - 8.5 x 12.5 x 8 in. wire cages containing ignited paper. (Dotted lines indicate posttest locations)
 ☆ Ignition sources

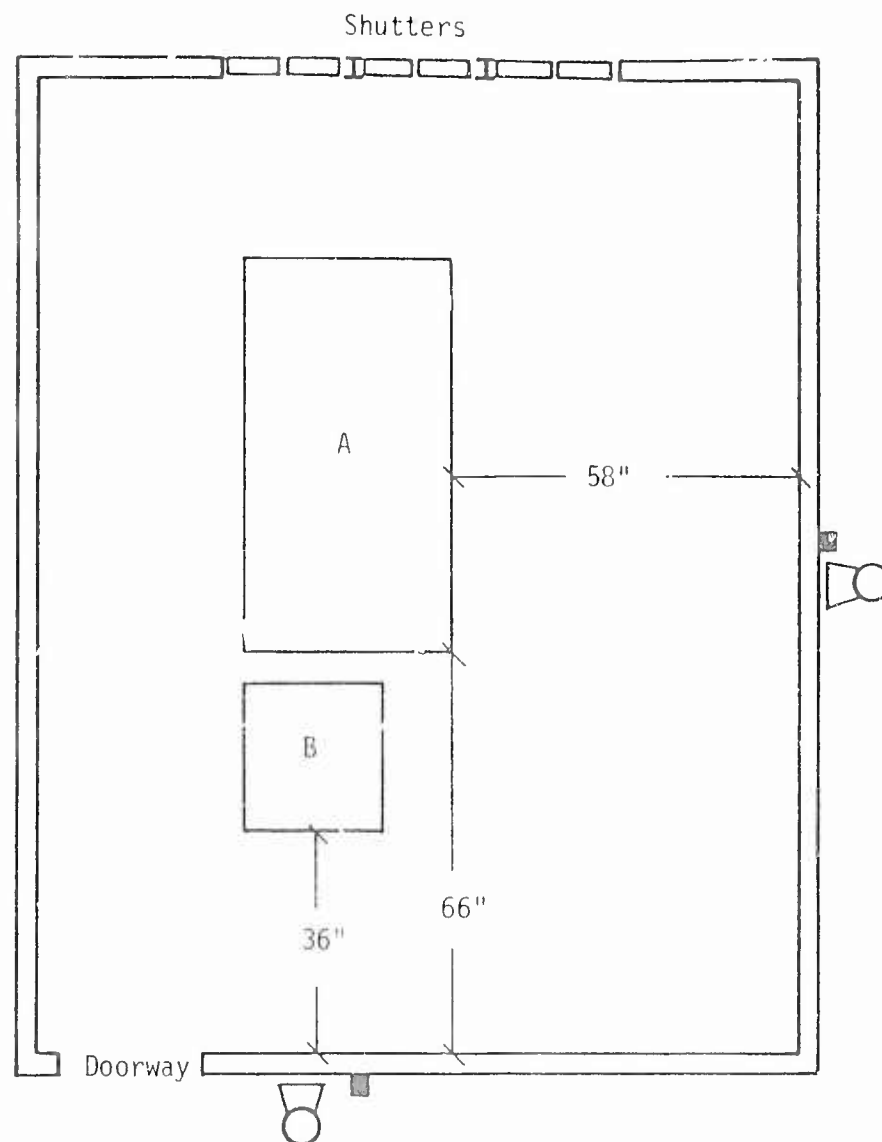
Fig. 17-1. Sketch of Test Geometry, Test Number 17

A - 36 x 66 in. desk containing three telephones and three radios

B - 24 x 24 in. communications rack

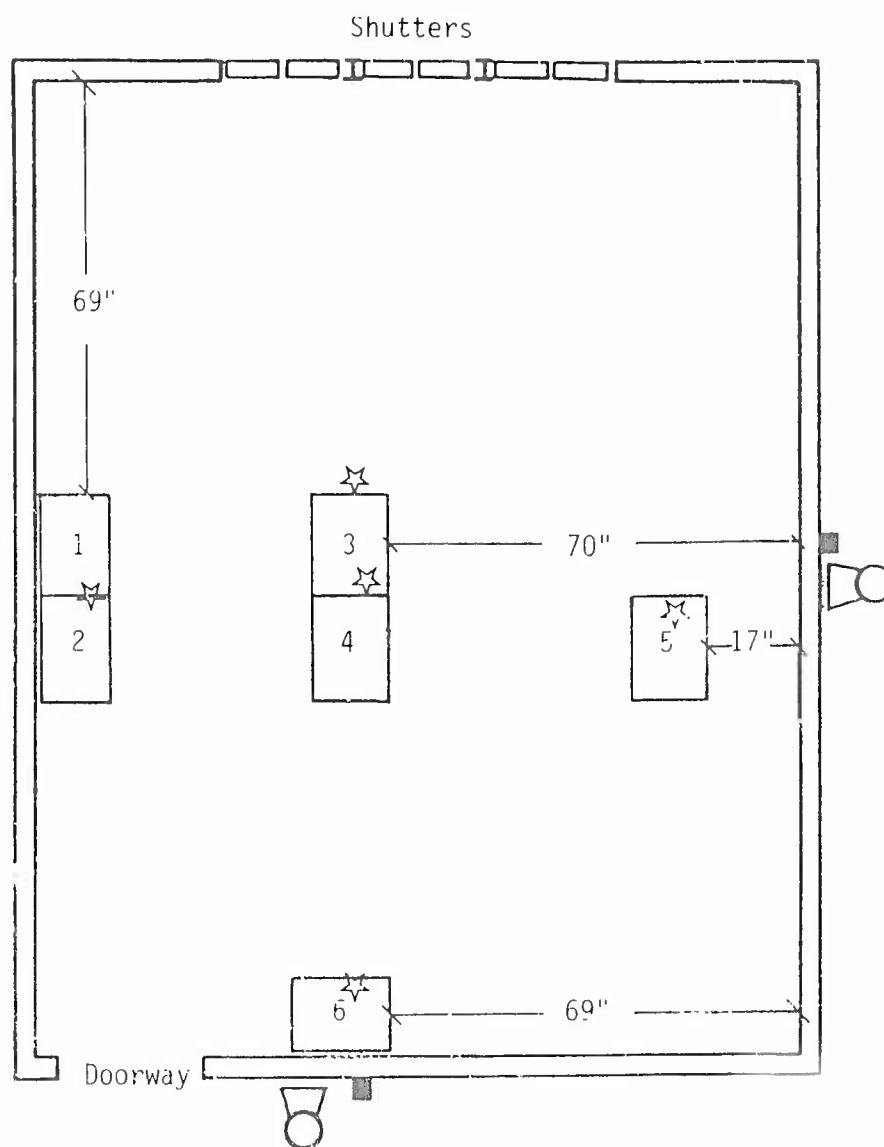
Fig. 18-1. Sketch of Test Geometry, Test Number 18

- 1, 2, 5, & 6 - 17 x 13 x 13 in. cardboard boxes (weighted, no paper)
- 3 - 17 x 13 x 13 in. cardboard boxes stacked three high (full of paper)
- 4 - 17 x 13 x 13 in. cardboard boxes stacked three high (top full of paper)
- ☆ Ignition sources

In contrast, all fires in the weighted boxes were not extinguished. The two side boxes (numbers 1 and 2 in Fig. 18-1) were flaming within 30 seconds after the shot and the box near the other side wall (number 5) was smouldering, although the smouldering fire did eventually go out.
